MEMORANDUM REPORT ARBRL-MR-03338

BLAST LOADING OF CLOSURES FOR USE  
ON SHELTERS-II

George A. Coulter

February 1984

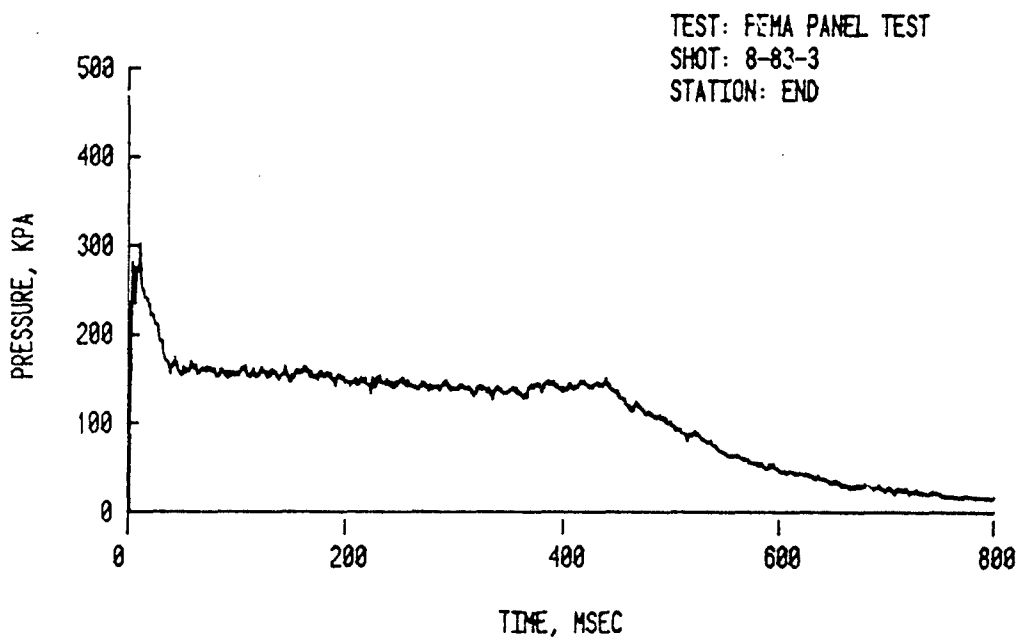
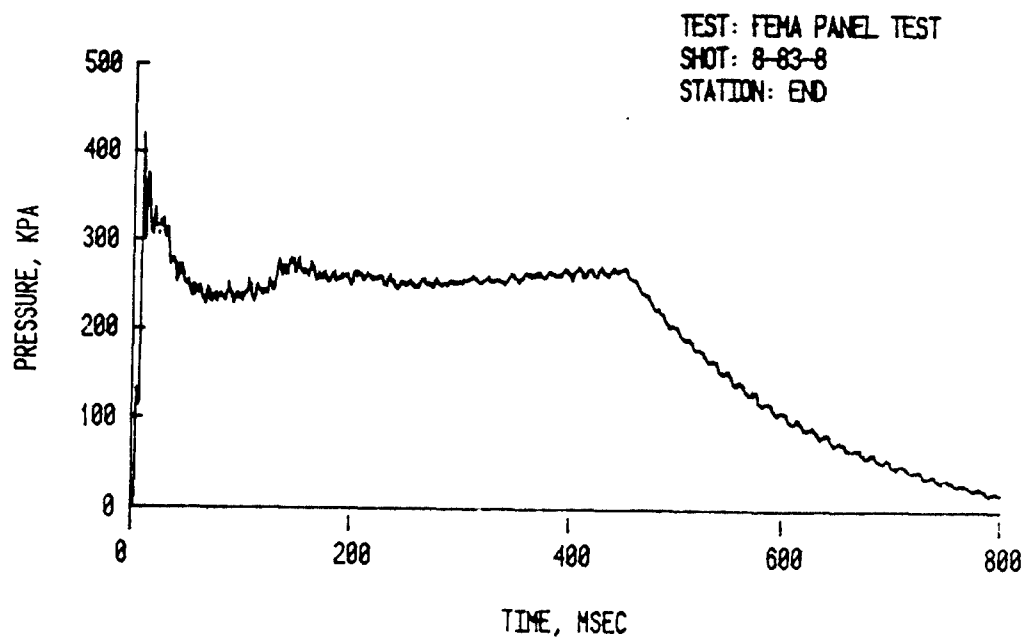
Figure 7. Input Loading - Time Records.

The loading records are shown in Figure 7 in order of the shot sequence. Shots 8-83-2 and 8-83-3 are for the two aluminum panels. Shots 8-83-4 and 8-83-5 are for the two pine beam closures. Shot 8-83-6 is for the oak planks with sand bag protection. Shot 8-83-7 is the input for the oak beam closure. The increase in pressure after about 150 ms is caused by the cold gas part of the shock wave loading the closure. All the other pressure-time records show a decay in pressure after the shock front, caused by the closures breaking. A rarefaction wave from the opened closure partially decays the expected flat topped input wave.

Shot 8-83-6, with sand bags, is obscured with flying sand very quickly in Figure 11. The sand bags effectively delayed the breaking of the oak planks; very little debris exited before 70 ms. The pressure-time record for Shot 8-83-6, Figure 7 above points this delay out also.

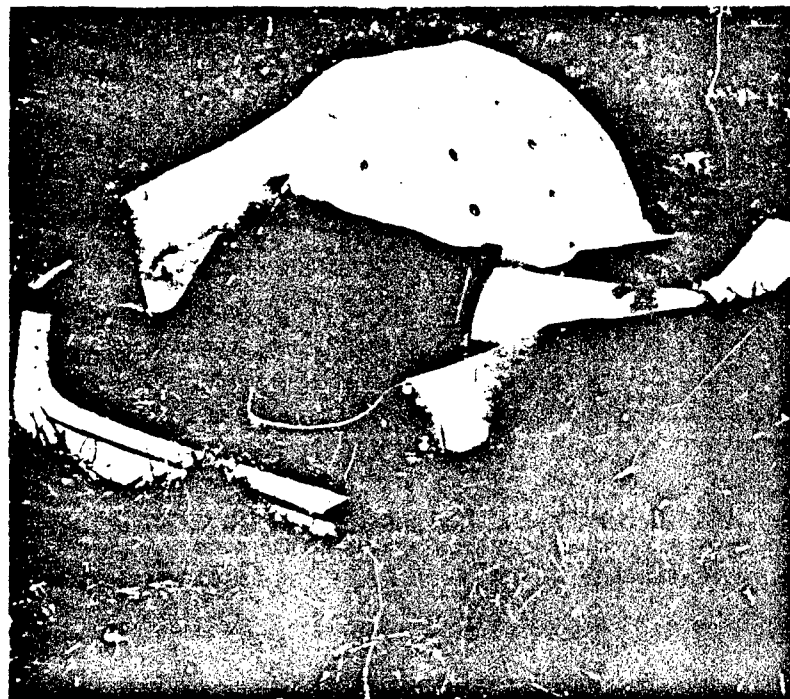
Figure 12. Failure Mode for Aluminum Closure - 247 kPa (35.8 psi).

Figure 12 illustrates the mounted closure in the upper picture and portions of the closure in the lower picture after exposure to the shock wave. Almost without exception, the plug welds broke from the I-beams without leaving the skins. Neither of the two aluminum closures tested were satisfactory for the key worker blast pressure levels.

It is felt by the author that only near-perfect No. 1 and better wood timbers could be used for closures at the upgraded pressure level. The welds joining the aluminum skin/I-beam closures failed also at this level.

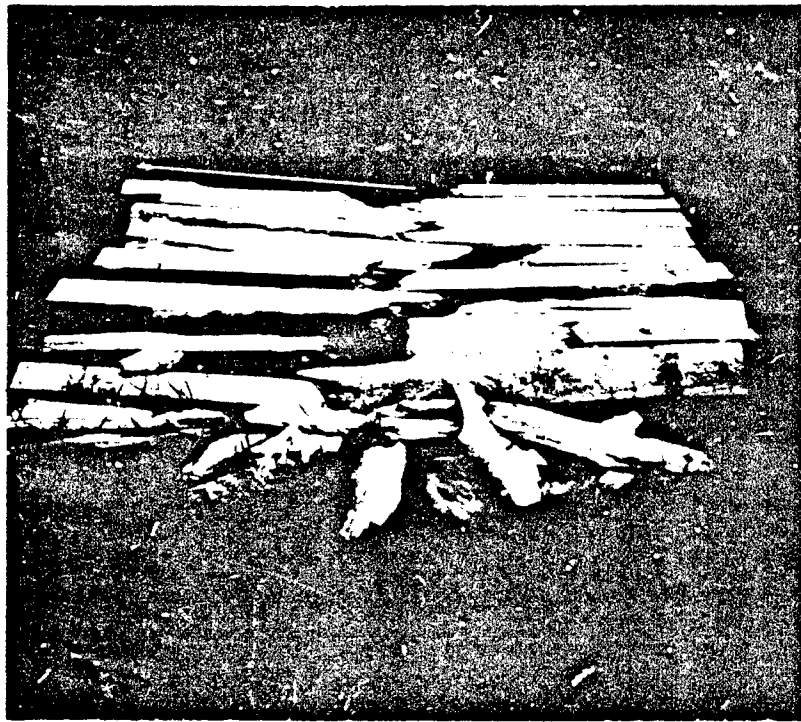
Figure 13. Failure Mode for Pine Beam Closure - 347 kPa (50.3 psi).

Figure 13 shows results from the tests of the pine beam closures. The failure was primarily about the flange opening's vertical centerline. The scattered broken beams were gathered from over the test area for this posed picture.

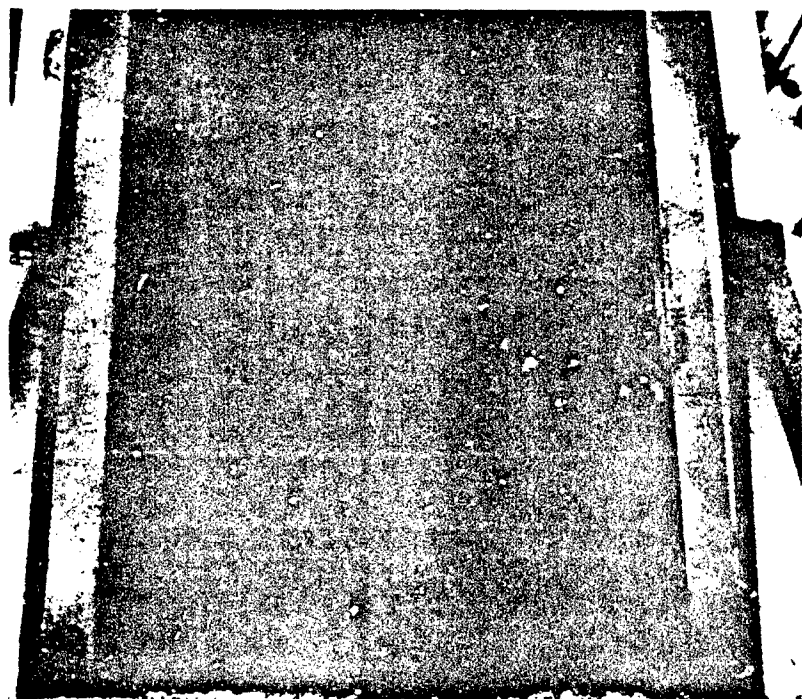
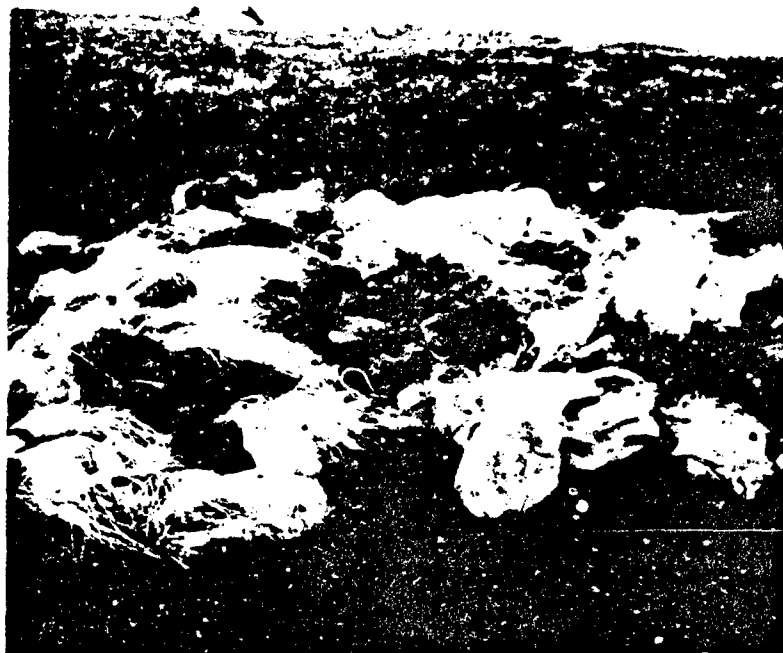
Figure 15. Oak Plank/Sand Bag - 344 kPa (49.9 psi).

Figure 15 shows the results of the oak plank/sand bag closure. As noted from the high speed photographs, failure did not occur until after perhaps 50 ms. This closure was just on the borderline of being satisfactory. One beam did remain in the test fixture but all sand bags were blown out. Figure 15-C shows the shredded state of the sand bags collected after the shot.

As noted previously in the results section, only one shot was fired with the sand bags in place. The closure did fail but only after a relatively long time. The curve for "closure - with sand bags" can at best be considered marginal at the test level of 345 kPa.

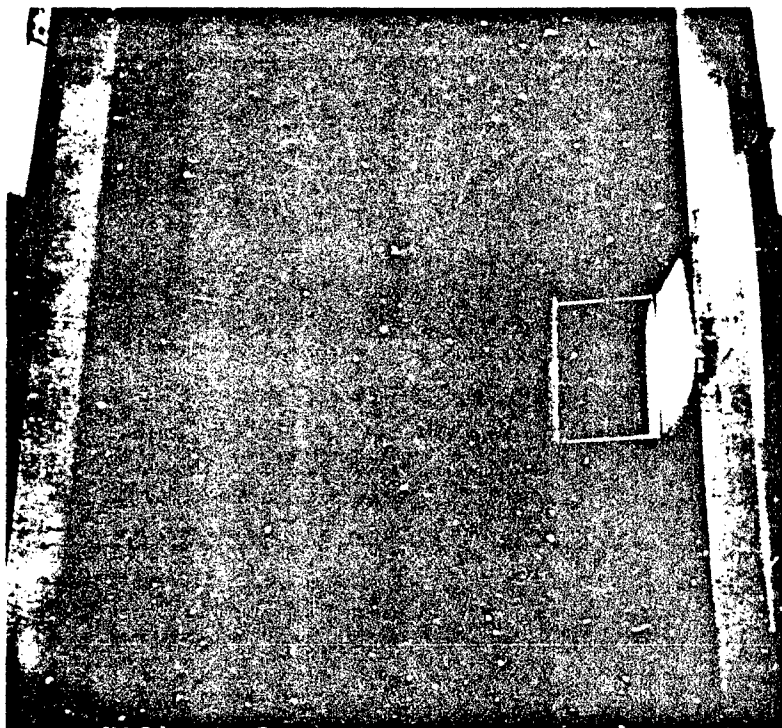
Figure 16. Oak Beam Closure, 76.2 cm (30 in.).

Finally, Figure 16, shows the method of mounting the oak beam closure over a 76.2 cm (30 in.) opening. The mounting braces and the closure were completely removed during the blast wave exposure. It is felt that the closure did contain the blast for a short time (perhaps 30 ms) until the steel side mounts were torn loose. The closure might have withstood the blast loading if the side mounts had remained intact. The plank/sand bag closure is considered to be marginal at the pressure level tested.

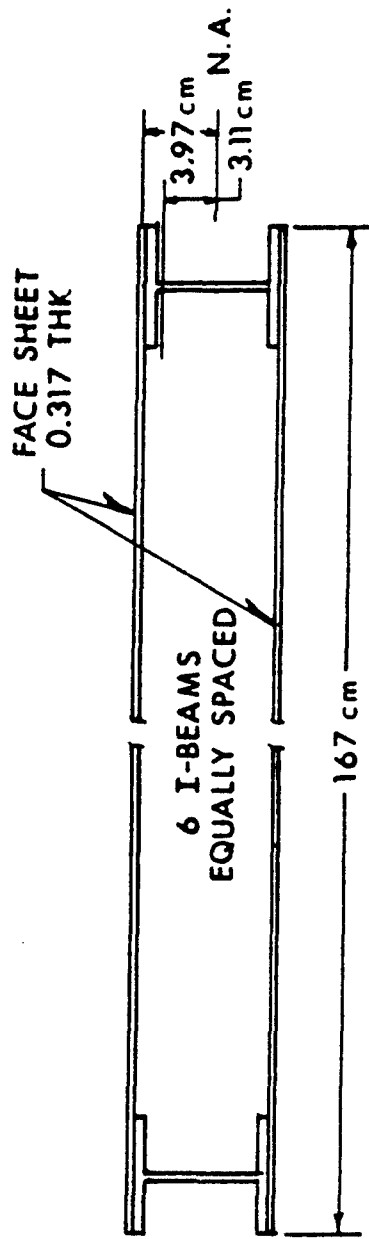
$E$ kPa	$I$ $\text{cm}^4$	$A_{II}$ $\text{cm}^2$	$d_I$ cm	$d_{I2}^2$ $\text{cm}^2$	$A_{II} d_I^2$ $\text{cm}^4$	$I + A_{II} d_I^2$ $\text{cm}^4$	$E(I + A_{II} d_I^2)$ kPa - $\text{cm}^4$
FACE SHEET	$68.95 \times 10^6$	0.44	53.01	3.97	15.74	834.62	835.06	$5.75 \times 10^{10}$
I-BEAM	$68.95 \times 10^6$	632.46	60.38	0.00	0.00	0.00	632.46	$4.36 \times 10^{10}$

$$EI_g = 15.86 \times 10^{10} \text{ kPa} - \text{cm}^4$$

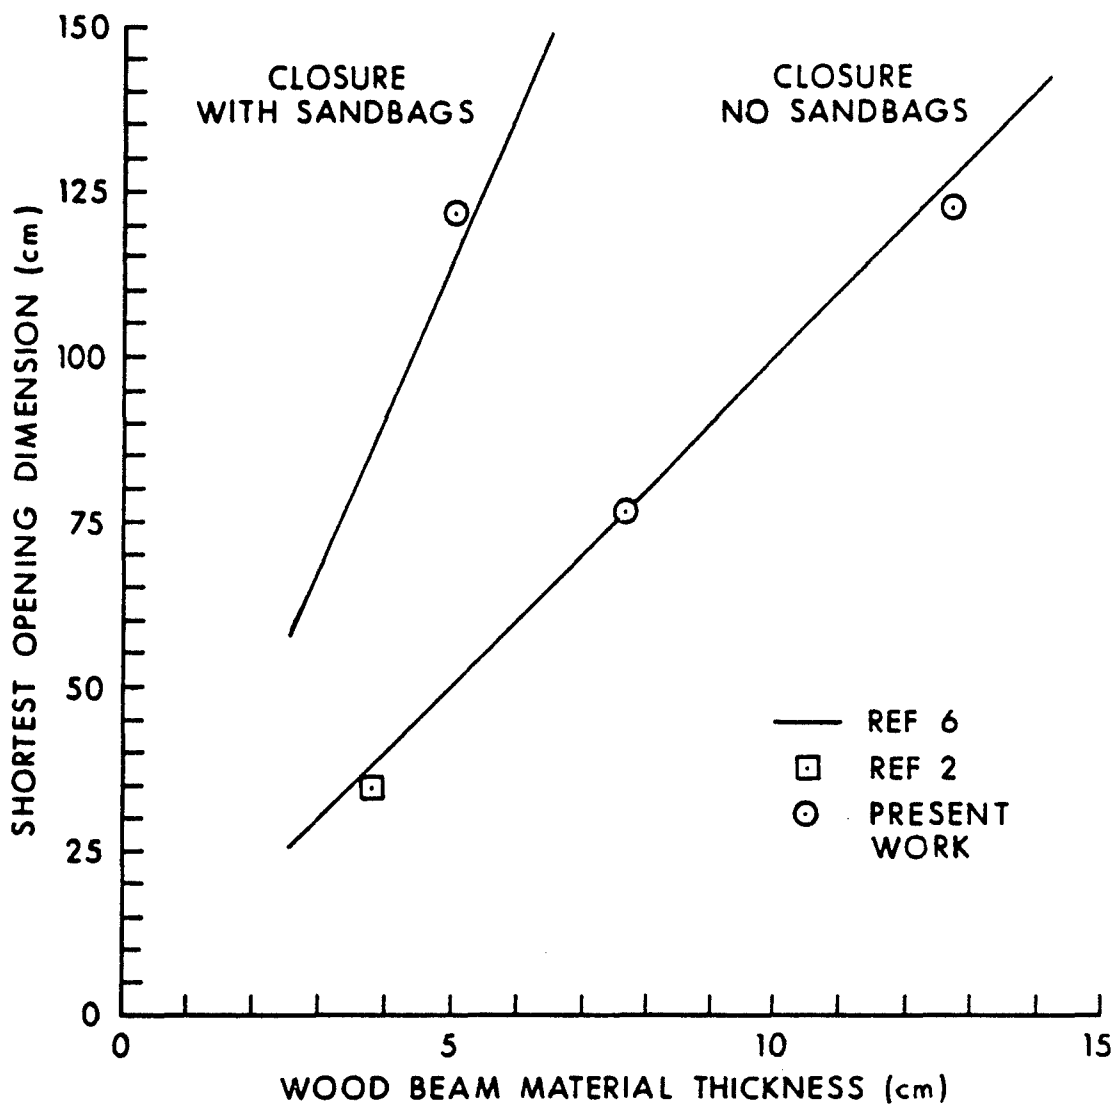
Figure 18. Material Thickness Required to Close Various Openings at the 345 kPa Ground Range.

The closures, with no sand bags as noted, did survive with minimal damage at the stated level. There would however have been almost no safety factor remaining since one timber member was cracked during the shots. It is felt, however, that both curves of Figure 18 would have been accurate for the level of 276 kPa as originally presented in Reference 6. The results of these tests indicate the curves should not be upgraded to the higher level of input blast pressure.

It is recommended that the particular materials versus opening size curves not be upgraded to a higher pressure level. No margin of safety is believed to exist at the higher level tested. Protection at this pressure level (344 kPa) could not be expected with most available lower grade materials. Revised curves should be published if the higher pressure level is desired by the FEMA project office.
